## **HIGHWAY ACCIDENT REPORT**

**FORD CONSTRUCTION COMPANY  
TRUCK—SEMITRAILER/DODGE VAN COLLISION  
MARION, NORTH CAROLINA  
MAY 12, 1977**

**REPORT NUMBER: NTSB-HAR-78-3**

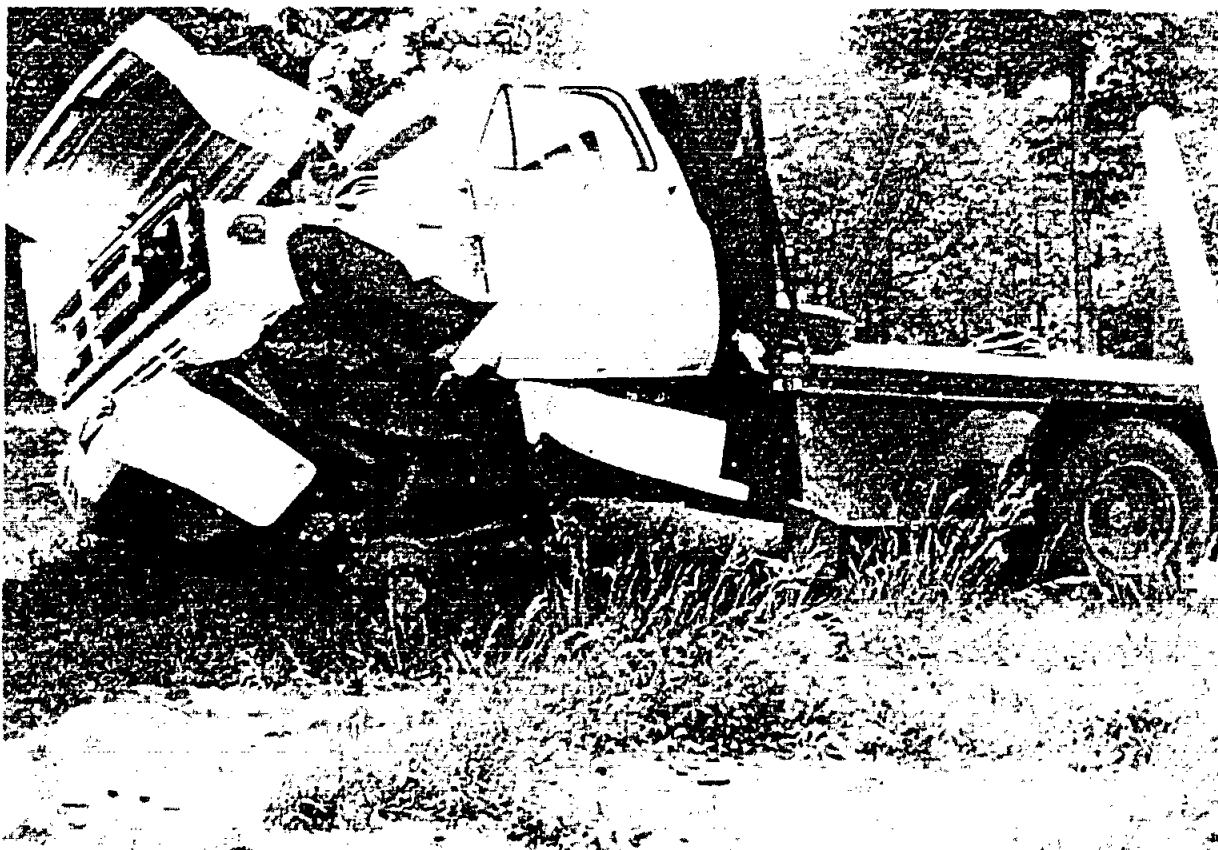
Figure 2. Truck involved in accident.

The truck was damaged when it struck the tree; the truck did not contact the van. (See figure 2.) There was extensive damage to the left-front bumper and suspension system. The frame was bent and twisted and the rear section of the drive shaft was disengaged from the rear axle carrier at impact. The right-rear tires were flat. The right side of the rear axle had been forced rearward and the left side had been forced forward.

There was minimal wear to the brake linings on all four wheels. All of the linings were glazed and discolored. Some areas of the brake drums also were discolored. The brake backing plate and assemblies were thickly covered with lining wear residue. While this residue is normally produced from lining wear during braking, the amount of material present seemed excessive given the limited mileage on the truck. The brakes were in adjustment. A brake lining sample was analyzed by the manufacturer and the lining material was found to be within manufacturer's specifications. Tests indicated that the surface of the lining had been exposed to high operating temperatures conducive to brake fade. The linings of the parking brake assembly, designed to lock the drive shaft when the vehicle is parked, also appeared to have been overheated.

Considerable wear and burring were evident on the low-range teeth of the rear axle shift sleeve coupler. There was also wear on the low-range shift anchor teeth. Wear to a lesser degree was evident on the teeth of the high-range side of the coupler. The rear axle shifted smoothly when it was removed from the truck and bench-tested. The end of the plastic casement surrounding the steel cable that was connected between the 2-speed shift button in the cab and the vacuum control valve on the left side rail was found broken where it attached to the vacuum control valve. This observation was made after the cable and transmission had been disassembled from the truck. This break was attributed to the relative displacement of the cab and the vacuum control valve during the crash. Several gear teeth on the second gear of the transmission had shave marks or indentations which were thought to have been produced during manufacture; however, these did not affect the smooth rotation or operation of the gear train when it was manually manipulated. The engine of the truck was started and found to be in running condition up to operation of the governor.

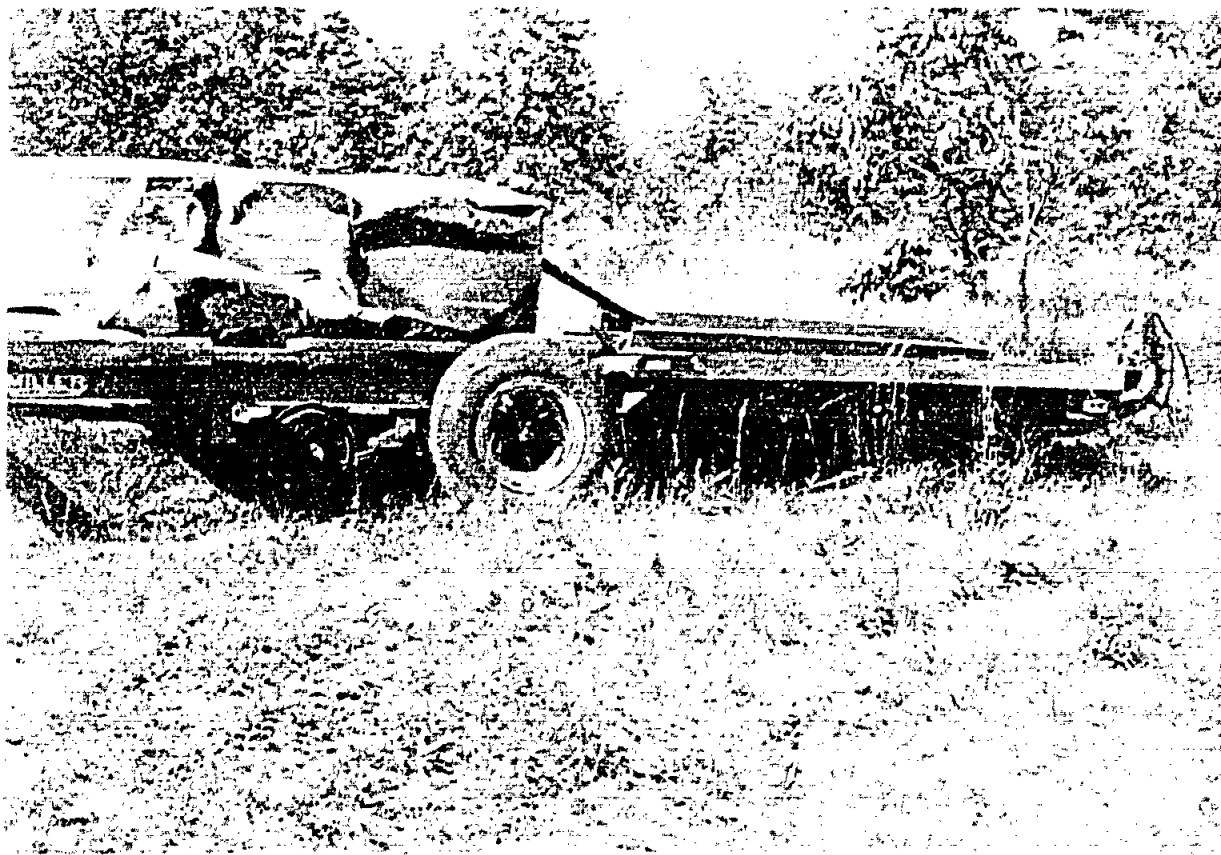
Figure 3. Semitrailer involved in accident.

The semitrailer -- The utility semitrailer was a 2-axle, 4-wheel lowboy flatbed manufactured by Miller Tilt Top Trailer, Inc. (See figure 3.) It weighed 3,230 pounds and was rated for a maximum capacity of 22,000 pounds. It was equipped with a lunette eye-type towbar for towing by vehicles equipped with pintle hooks. It was designed for intermittent highway use at a maximum speed of 50 mph and was equipped with electrically-actuated brakes.

During the crash sequence, three of the four wheels of the semitrailer disengaged from their axles when struck by the loader-backhoe tractor as it fell off the trailer. Damage associated with contact by the loader-backhoe tractor was found along the inside sidewalls of the tires. The right-rear anchor bracket, used to anchor the restraining chain holding the rear of the loader-backhoe tractor in position, was torn from the semitrailer. The steel flanges around the semitrailer bed were bent, apparently from forces transferred through the restraining chains.

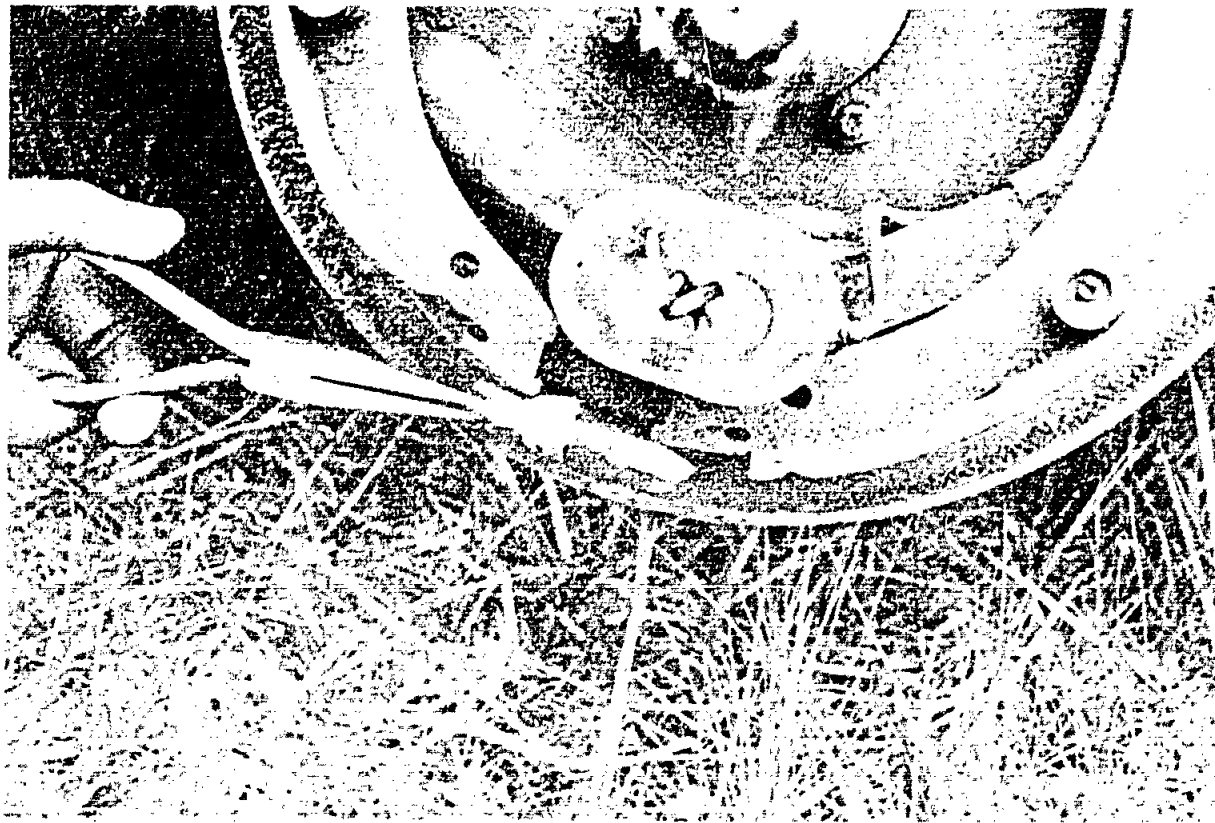
The semitrailer's electric light wiring system was tested and found to be inoperative because its ground wire was connected to a rusty bolt. The electric circuit for actuating the brakes on the two right wheels was functional; however, the brakes on these right wheels were inoperative. The adjusting screw for the right front brake was found detached and loose in the drum. (See figure 4.) A bent nail had been inserted to hold the magnet in place; this nail protruded beyond the magnet, thereby preventing contact with the drum. (See figure 5.) The brake lining was in very poor condition. The right rear brake had functioned recently; this was indicated by abrasive wear from its magnet rubbing against the brake drum. However, testing revealed that the magnet had a restraining wire that prevented it from contacting the drum at the time of the accident. (See figure 6.)

Figure 4. Right-front wheel of trailer. Note detached brake adjusting screw and wear from running loose inside the drum.

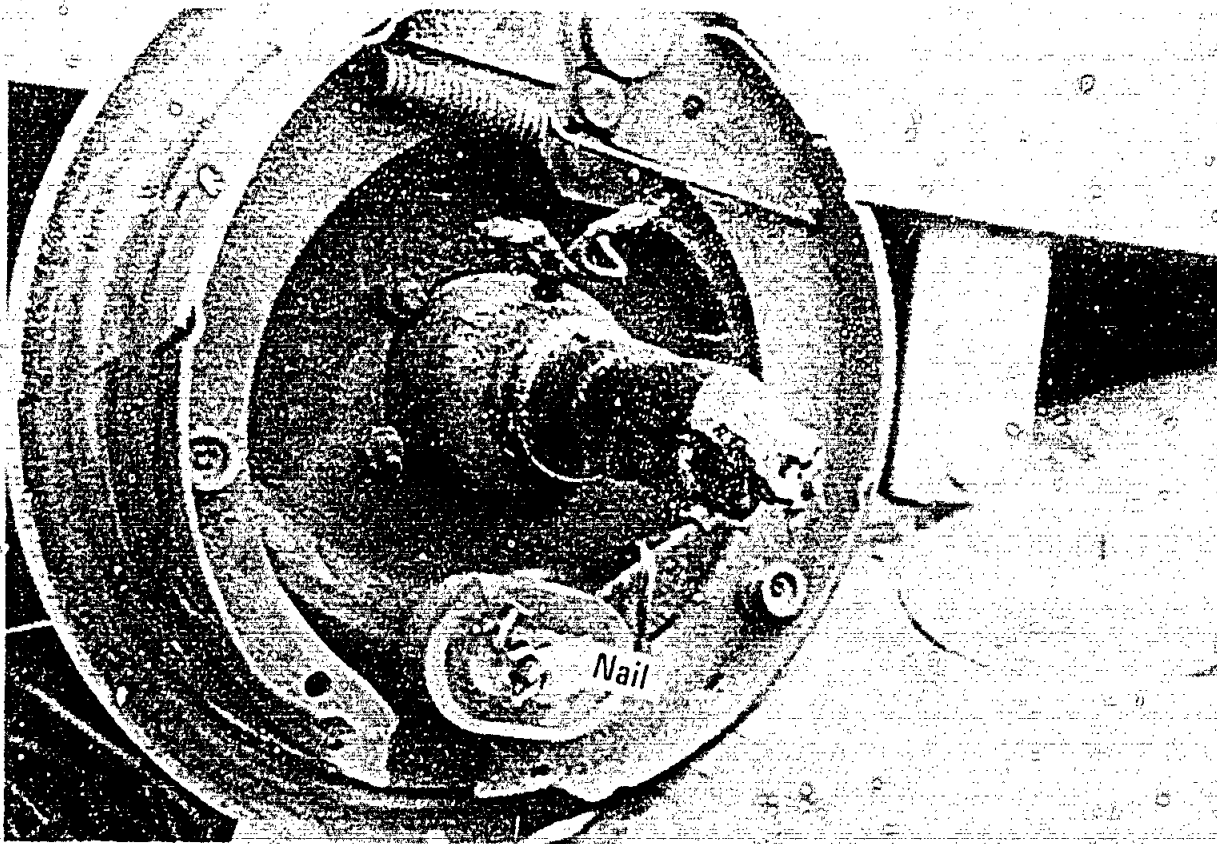
Figure 5. Right-front wheel of trailer. Note nail used to hold magnet in place. Lining condition may have been impact related.

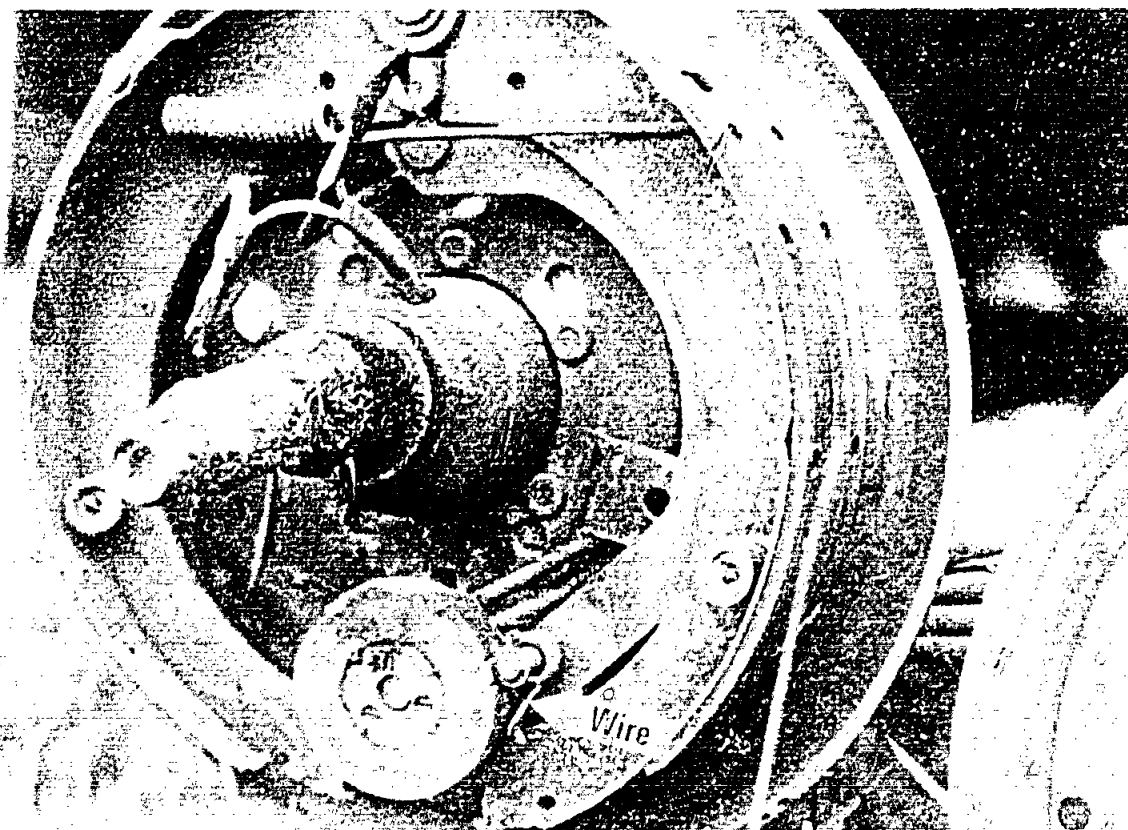
Figure 6. Right-rear wheel of trailer. Note wire used to hold magnet in place.

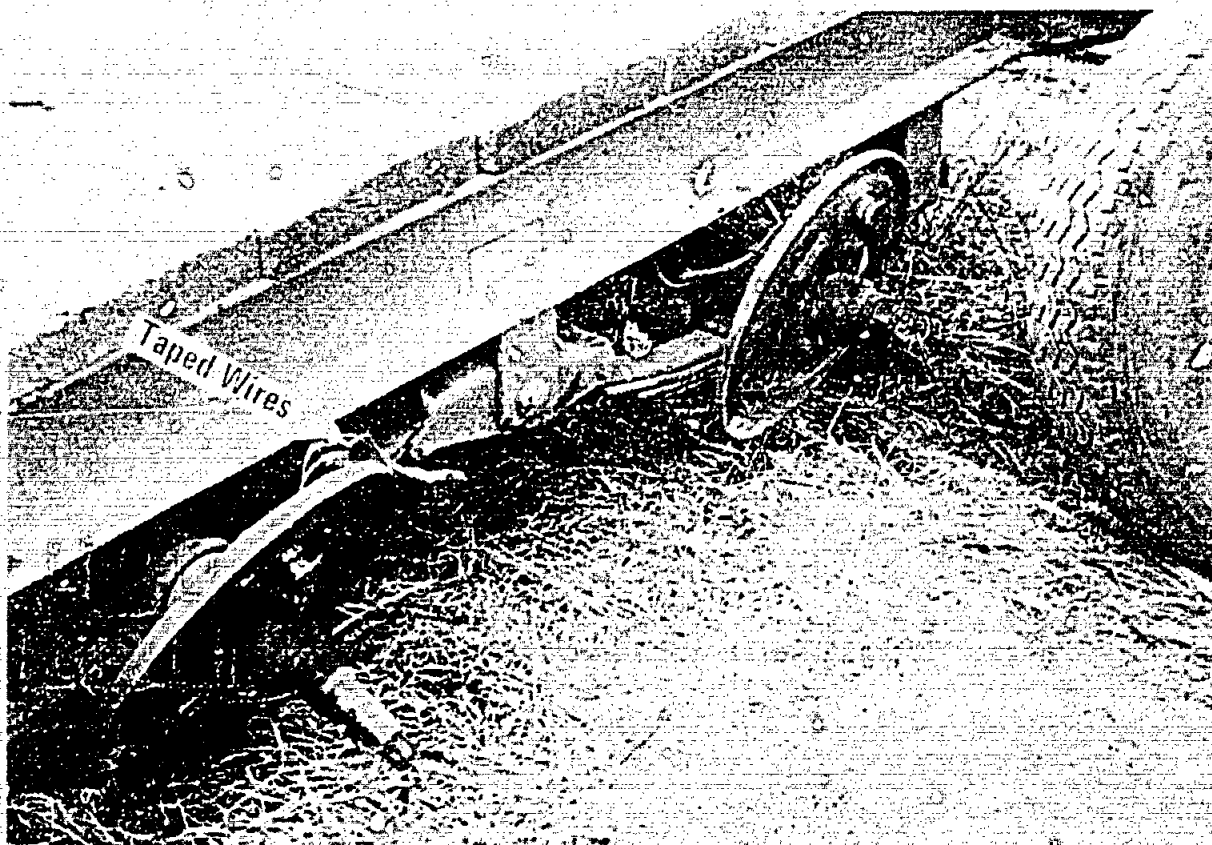
The brakes on the two left wheels were missing. The electric wires for these two left wheels had been taped together. (See figure 7.) The flatted truckdriver involved in this accident stated that he had removed the left-front brake assembly while "repairing" a wheel malfunction about 2 months before the accident and did not replace it. Since this wheel had begun to wobble while he was towing the semitrailer, he removed the wheel, took it to a shop for replacement of the wheel bearings, and remounted the wheel. He knew the brakes for this wheel were not functional, but did not repair them because he "did not know how to repair brakes."

Figure 7. Left-front (foreground) and left-rear (background) wheels of trailer. Note lack of brake assemblies; wires to left-front had been taped.

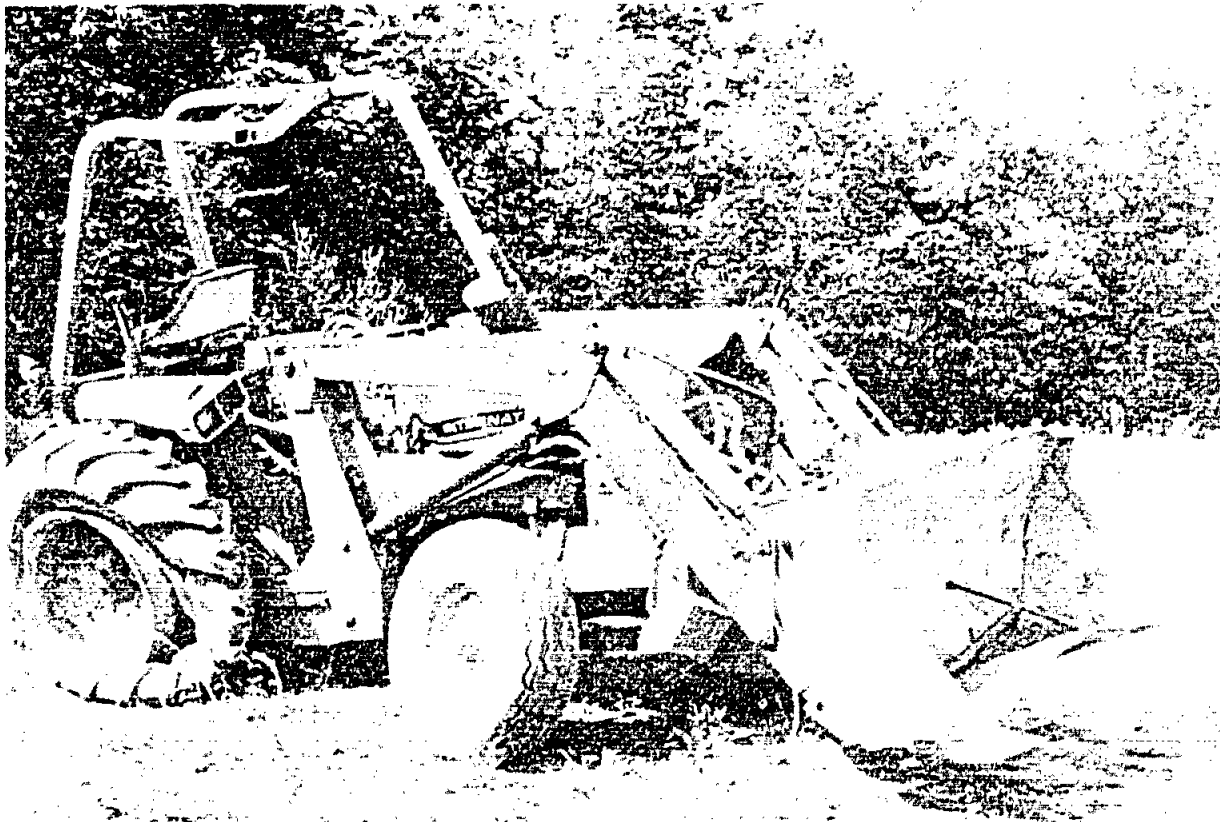
Figure 8. Backhoe involved in accident.

The loader-backhoe tractor -- The loader-backhoe tractor was a 1976 International Harvester tractor, Model 2514D, equipped with a hydraulic front-end loader and a rear boom with bucket. (See figure 8.) The unit weighed about 11,310 pounds with a weight distribution of 2,000 pounds on the front axle and 9,310 pounds on the rear axle when being transported. It was being transported with its rear end forward, which was an appropriate loading configuration.

According to company personnel, the loader-backhoe tractor was secured to the semitrailer with two chains. One chain each bound the front and rear of the unit. Chain binders were used to tighten both chains. The chains were about 20 feet long and had links made from 3/8-inch-diameter, high tensile strength steel. It was not possible to locate or positively identify all components associated with holding the unit in place on the semitrailer and their condition after the accident. Therefore, no precise description of how the loader-backhoe tractor broke free of the semitrailer could be established.
